## PT 2011

Office of Nuclear Regulatory Research

### Introduction

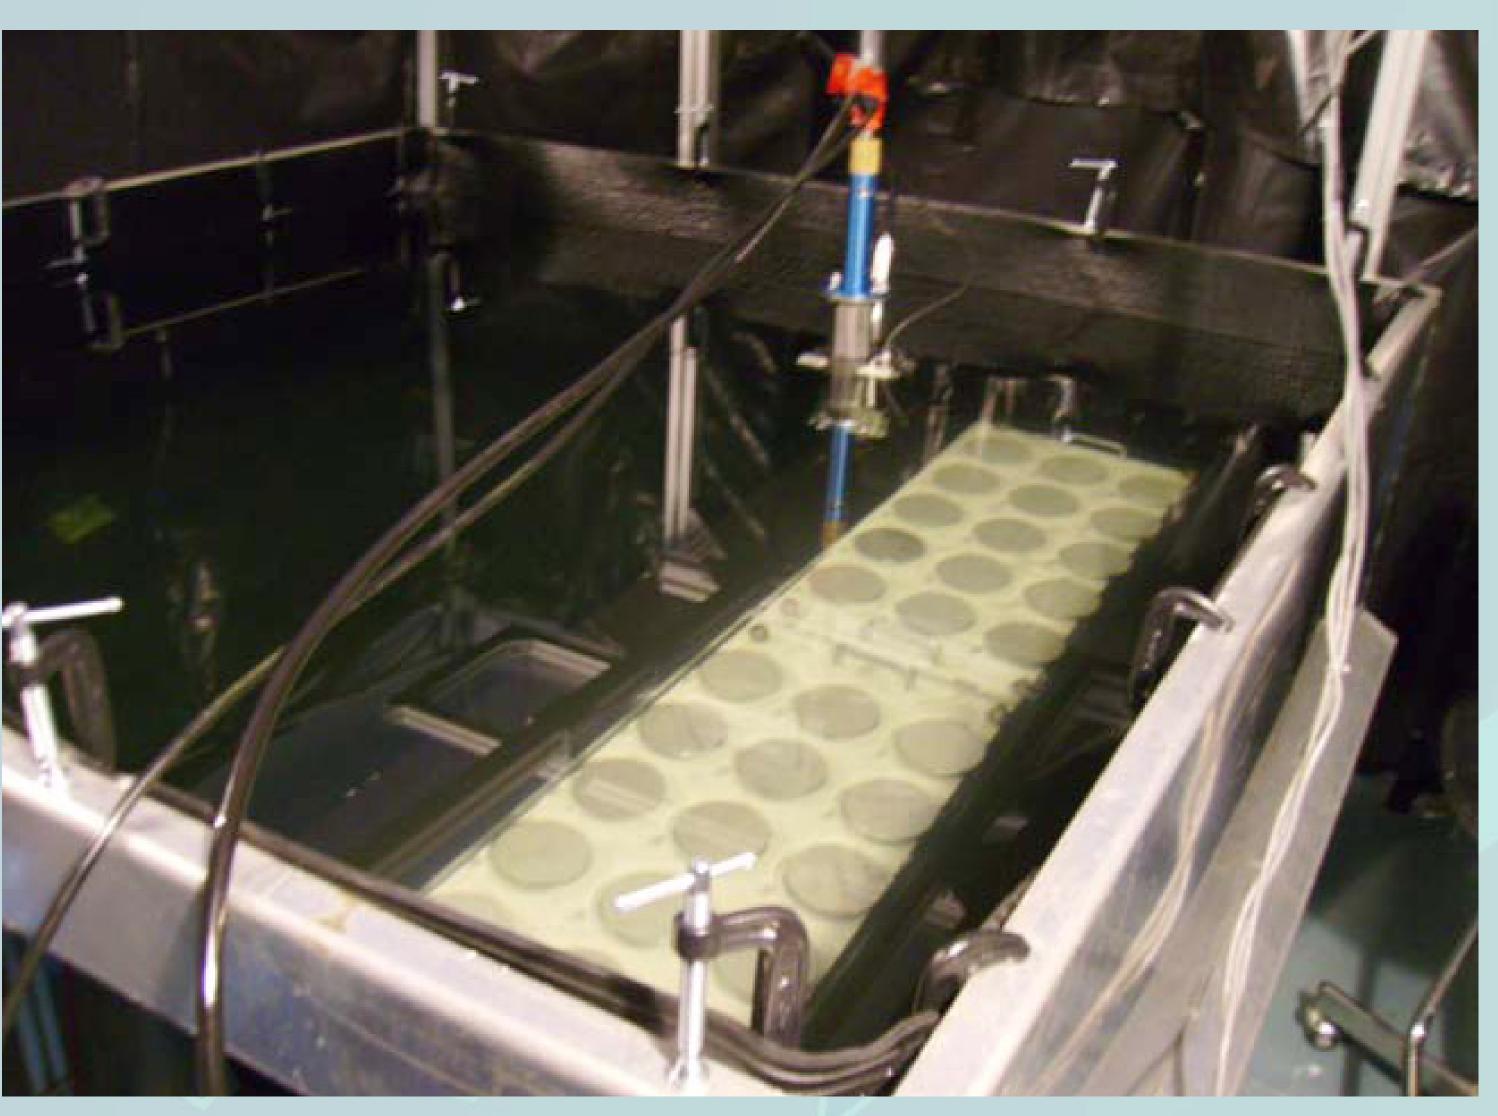
# Blank Sample Cracked Sample Crack Orientation Mark

The test samples were three-inch-diameter as-rolled stainless steel discs. Twenty-eight of the disks had a mechanical fatigue flaw implanted at the testing surface. Another 32 samples were left as blanks with no cracks.

The test samples were placed in holders and set in a tank of water for testing. The samples were placed in the holders in random order and in random orientations.

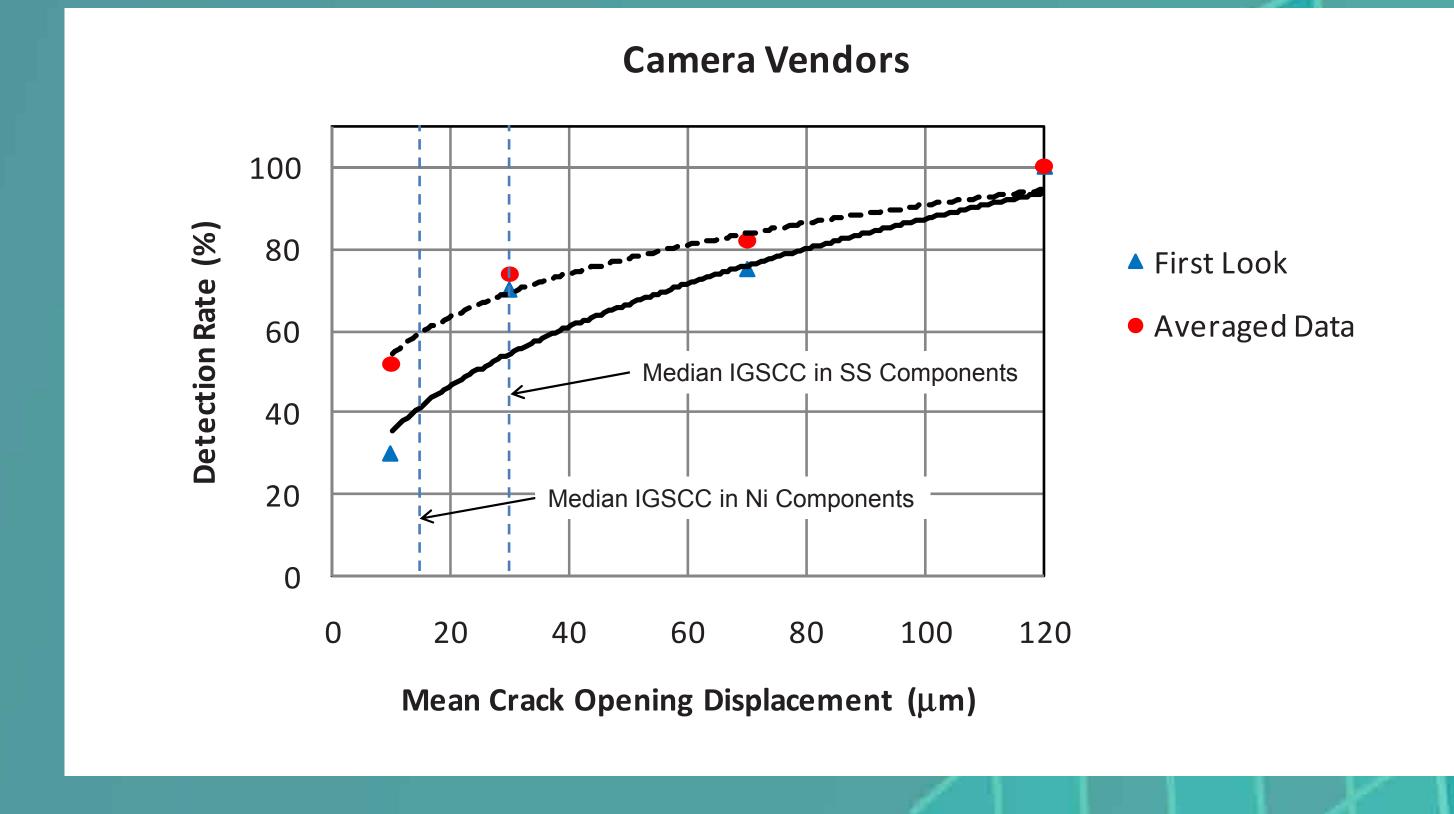
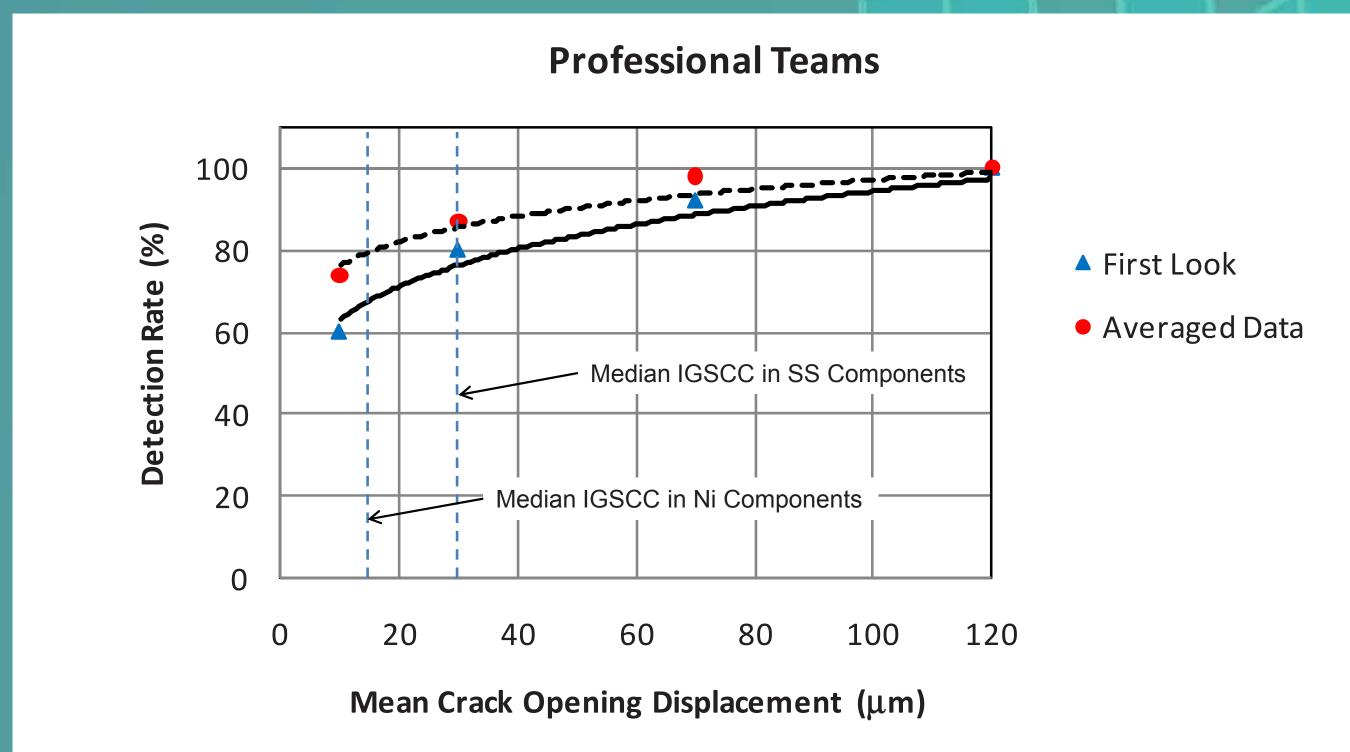
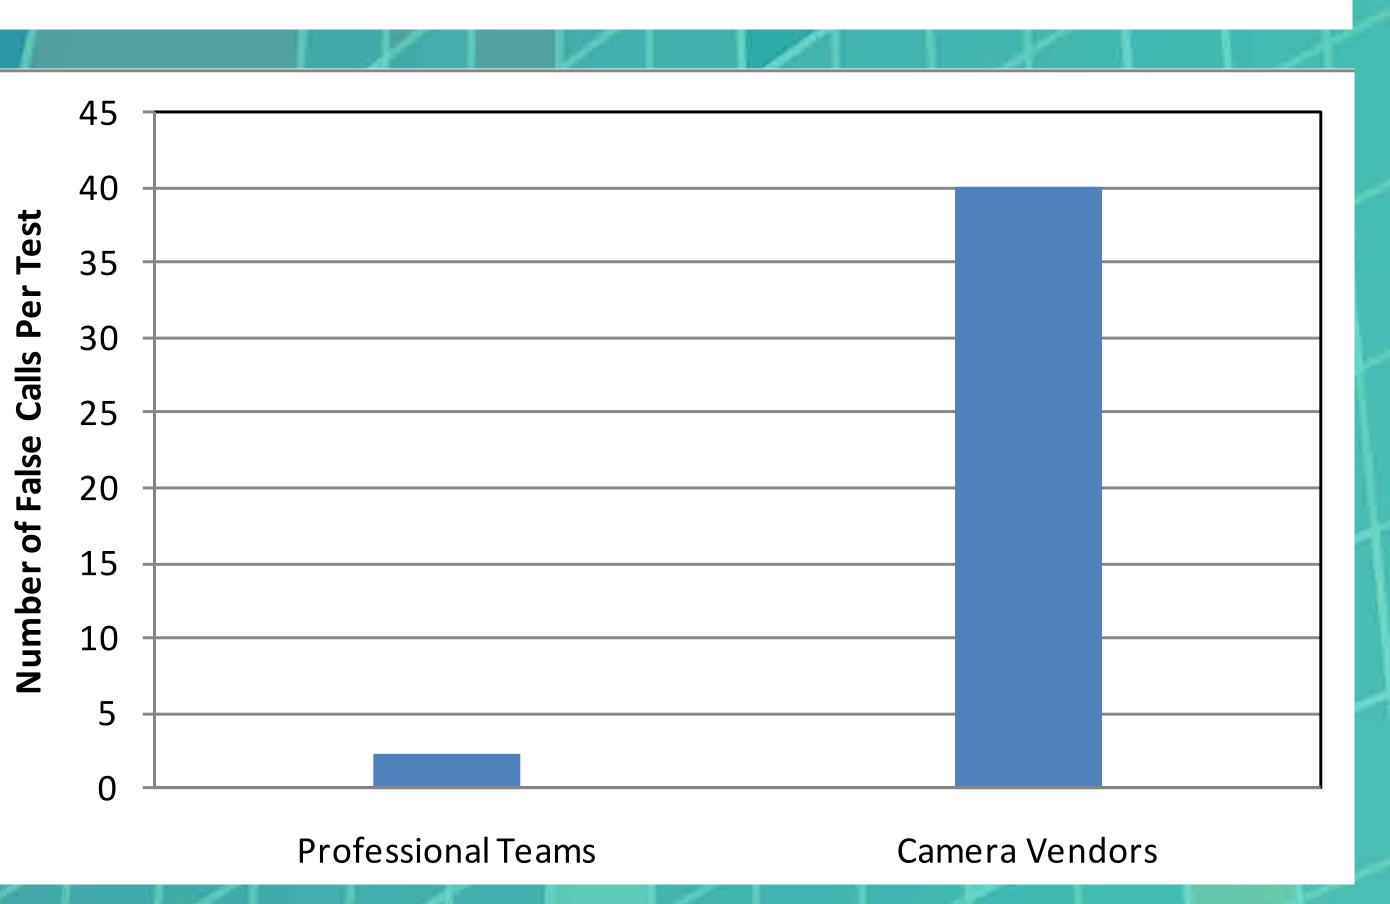
Phase 1 test results showed higher than expected detection rates based on previous work and literature. The higher detection rates appear to be the result of improvements in camera technology and the conditions under which the tests were taken (nearly ideal laboratory).

A review of the recorded data showed that all cameras used in the tests were able to image even the tightest cracks.

The results showed that additional analysis is required relative to COD. Defining a single COD to represent a crack of varying width may be insufficient.

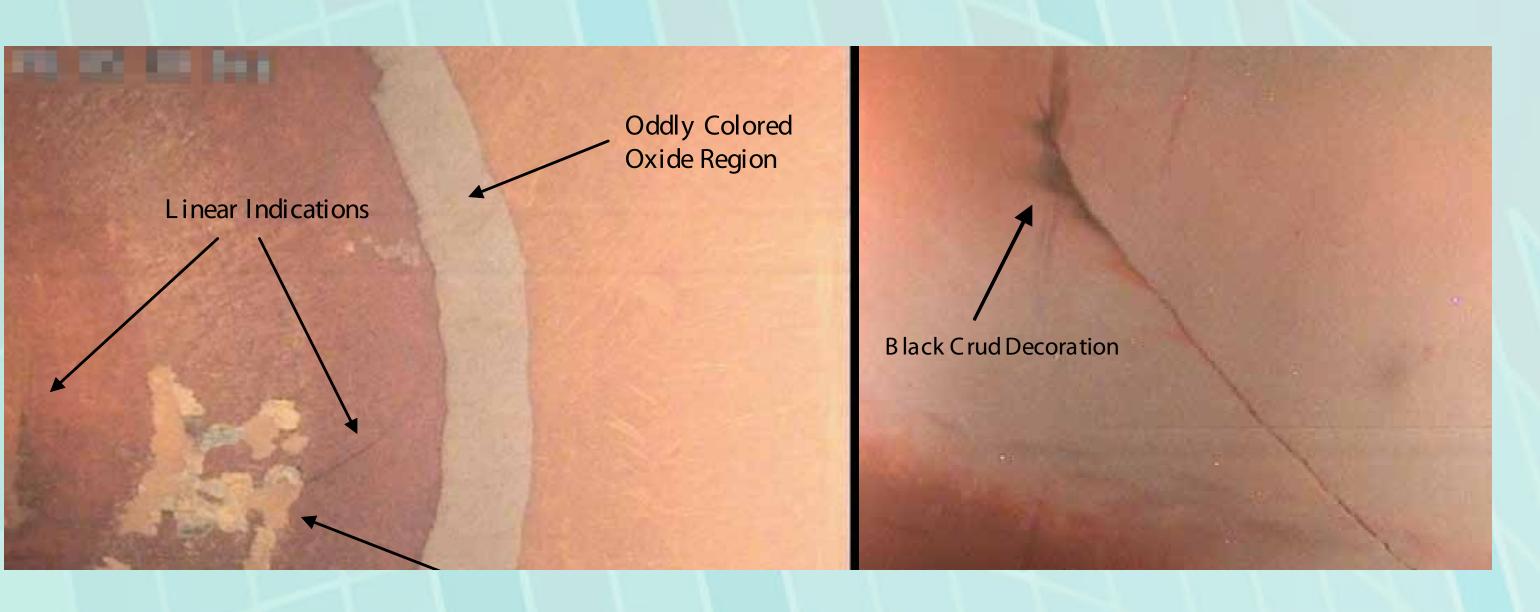
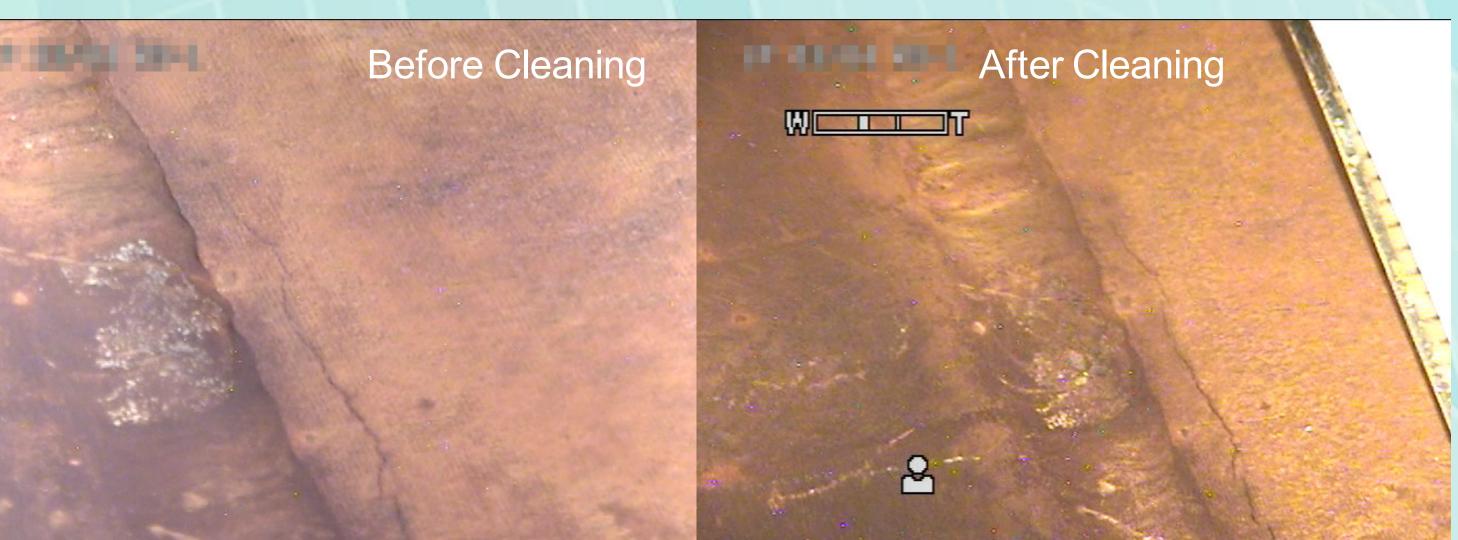
Cracks in vessel internals can be covered by deposits. In addition, radiation fields can affect image quality, and moving water can affect camera positioning.

Realistic surfaces present challenges not included in the Phase I tests.
